## Healthy Range Watersheds Critical to the Future of Texas

Water for Texans Series  
No. 2 August 1998

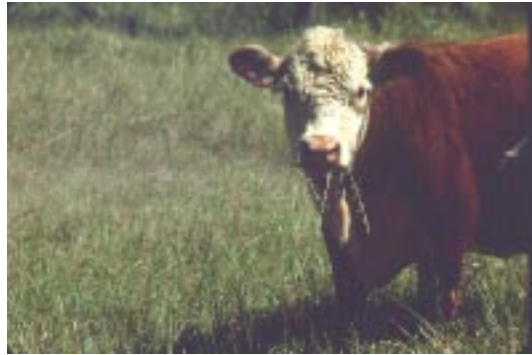
Properly managed rangeland has adequate vegetation cover to protect the soil from raindrop impact, promote infiltration, and slow and filter overland flow to minimize erosion.

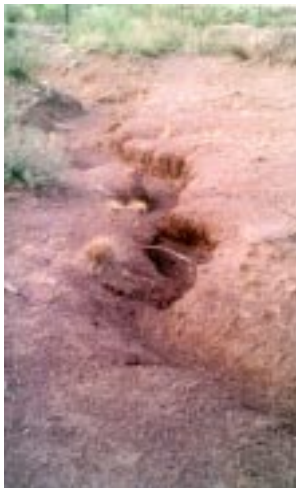
Photo by Allan McGinty

When conditions result in excessive overland flow from a rainfall event, surface erosion can occur and form gullies in accumulation areas.

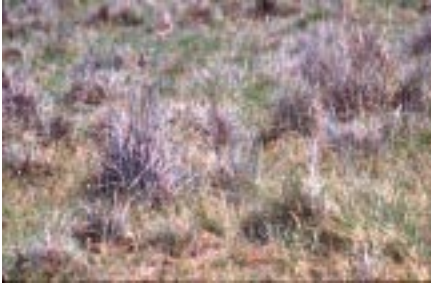
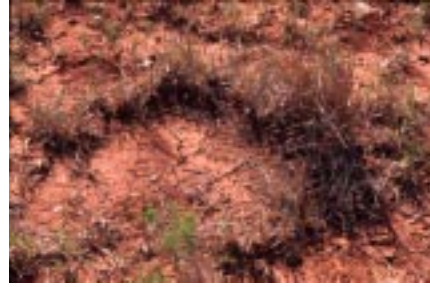
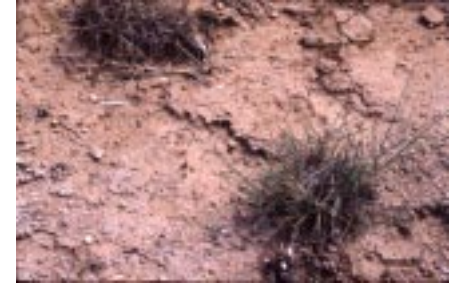
The above left-hand photo shows a range site with good plant distribution and minimal bare ground. This condition is important for slowing overland flow of water and sediment. Fragmentation of plants, an increase in bare ground and sediment accumulation at the base of plants, as shown in the center photo, indicate management should be adjusted before substantial degradation occurs. The right-hand photo shows results of sheet erosion with an erosion shelf formed by overland flow of water.

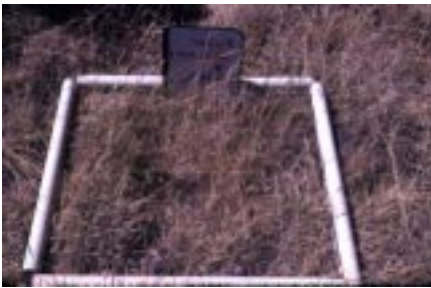
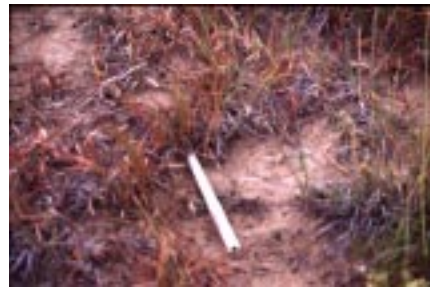
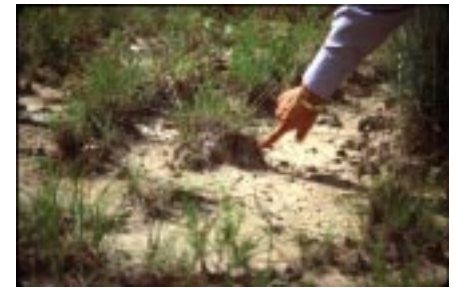
The above left-hand photo shows a range site with good cover, very little bare ground and no pedestaled plants (no soil has washed away from the base of a plant leaving the roots exposed). Plants in the center photo are becoming pedestaled with increasing bare ground. When these factors are present management should be reevaluated to prevent additional loss of topsoil and vegetative cover. The right-hand photo shows plants that are severely pedestaled (3-4 inches of topsoil gone) with the roots of the plants showing and a less productive soil remaining.

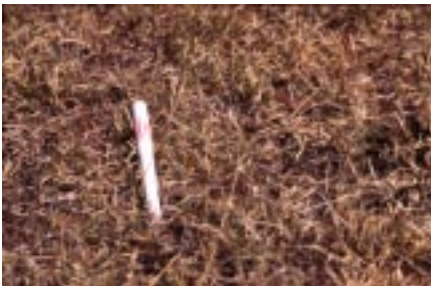
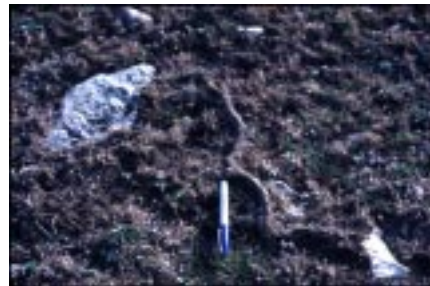
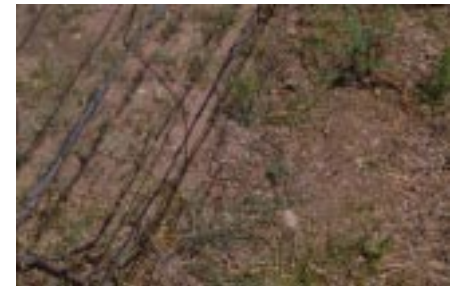
The above left-hand photo shows a short grass range site with good ground cover and evenly distributed litter. The center photo shows a litter dam that has formed due to water movement over the soil surface indicating that there was not enough vegetation left to slow water movement or promote infiltration. Management needs to be adjusted to prevent the further loss of soil, nutrients and organic matter, as shown in the right-hand photo where it has left the property.
